**GEOLOGICAL AND
HYDRO-GEOLOGICAL
STUDY
FORM D-I
PROJECT:
WEST ESTERILLOS
CONDOMINIUMS AND
VILLAS.
PARRITA, PUNTARENAS.**

Requested by: TECNOCONTROL S.A.

JULY 2007.

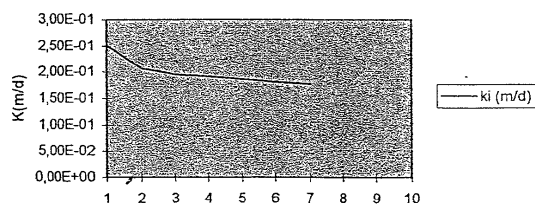
CASE: OPEN BASE IN UNIFORM SOIL

VARIABLE LOAD PERMEABILITY

TEST

ASYNTHOTIC VALUE = k = 1.78E-01 m/d
k = 2.05E-04 cm/s

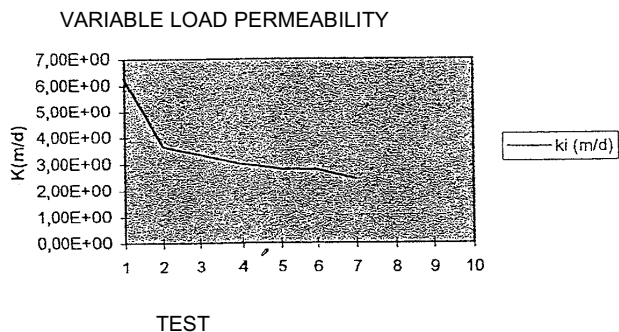
$$K = \frac{3.1416 \cdot D \cdot \ln(H1/H2)}{11 \cdot (t)}$$

CASE: OPEN BASE IN UNIFORM SOIL

ASYNTHOTIC VALUE = k = 2.46E+00 m/d
k = 2.84E-03 cm/s
